CONSERVATIVE RESTORATION OF FRONT TEETH

The development of composite materials capable of providing excellent mechanical characteristics and optimum aesthetics has allowed conservative restoration of elements which up until a few years ago required prosthetic treatment. The purpose of this study is to describe a restoration technique using a new nano-particle composite known as “PremiseTM”, (Kerr) a material composed of trimodal fillers loaded to approximately 84% by weight and 69% by volume.

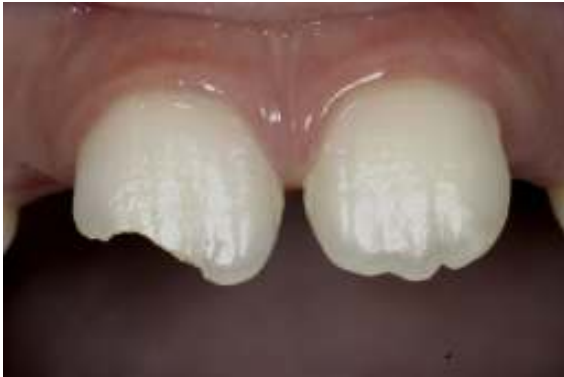
Fig. 1

Referred to us for examination on account of a traumatic fracture of 1.1 (Fig. 1).

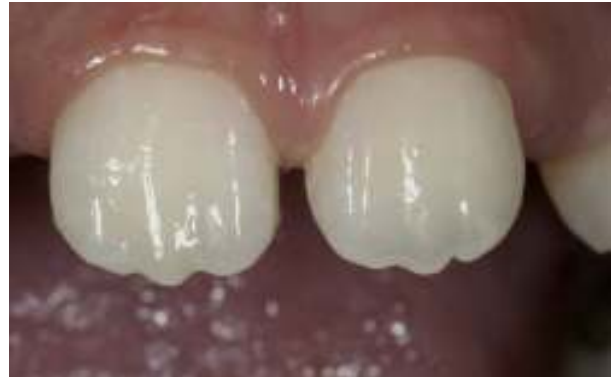
Fig. 2

After carrying out an X-ray and pulp vitality test the decision was taken to carry out a direct composite restoration. A matrix template was then fabricated in silicone for stratification of the composite material. The reconstruction then began with a thin layer of enamel A1 positioned in the matrix template in order to construct the palatal surface. Then with the addition of dentine A3 and A2 the internal structure of the mamelons was reconstructed. Super-clear translucent mixed with super colour blue was inserted into the invaginations between the mamelons and white XL1 was used to frame the incisal edge. At this point the restoration was completed with the application of a final layer of enamel. A1 (Fig. 2 – Clinical case completed).

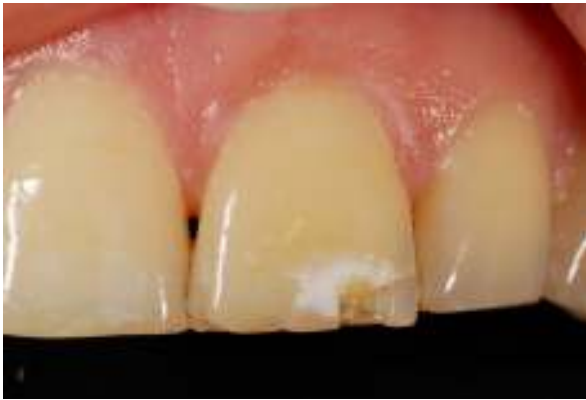
Fig. 3

Patient R. B. aged 28 requires the aesthetic and functional restoration of 1.1 (Fig. 3).

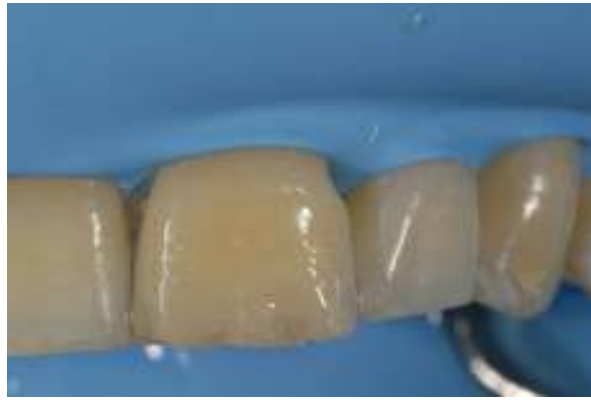
Fig. 4

After an analysis of the occlusion (protrusive and lateral excursion) a zone of wear can be clearly seen along the mesial margin of the tooth which would require grinding of the antagonist element in order to be reconstructed. With the agreement of the patient, who rejected the idea of grinding the antagonist, the decision was taken to reconstruct only the distal portion of the tooth where the enamel was broken off. After preparing the tooth composite modelling and stratification was carried out using dentine shade A3.5 in the first layers (Fig.4) and completing stratification by positioning a thin layer of translucent amber enamel (Fig. 5 – Clinical case completed).

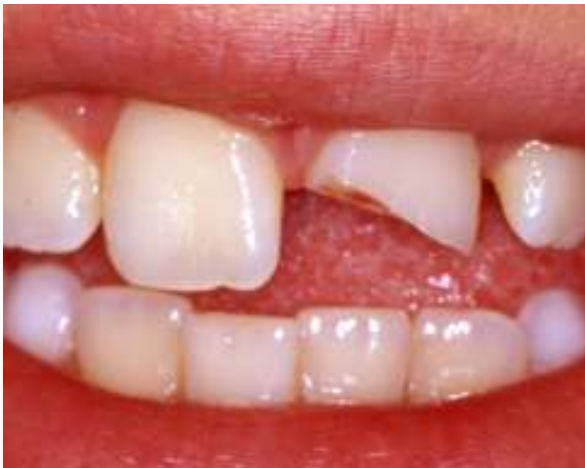
Fig. 6

Patient A. A. 9 years of age with a traumatic fracture of 2.1 (Fig. 6) and exposure of pulp horn.

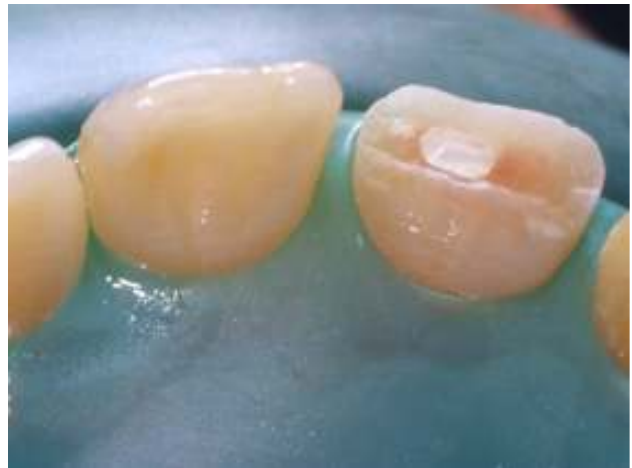
Fig. 7

In view of the patient's young age and favourable clinical conditions direct pulp capping was carried out using calcium hydroxide. Alginate impressions were then taken in order to construct the matrix template. In the next session, after checking the status of pulp vitality and having isolated the teeth with rubber dam, we proceeded to stratify the composite using A1 enamel to construct the palatine wall (Fig. 7). After removing the matrix template we proceeded to create the mamelons using dentine A3 and A2, and translucent super-clear mixed with a very small amount of super colour blue was inserted in the incisal margin. A thin line of white enamel XL1 was positioned along the incisal edge and the whole structure overlaid with enamel A1 (Fig.8 – Clinical case completed).

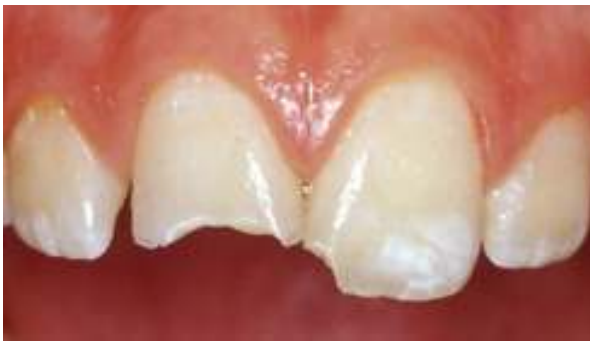
Fig. 9

Fracture of the 1.1 and mesial edge of 2.1 (Fig. 9).

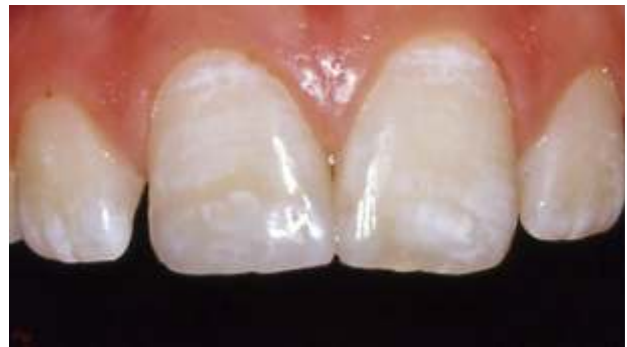
Fig. 10

Once again in this case a pulp vitality test was carried out first in order to ensure that tooth vitality could be maintained. After having carefully evaluated morphology and internal characterisation, the teeth were isolated with rubber dam. We proceeded to carry out reconstruction by inserting white enamel XL2 on the penultimate layer in order to recreate the wide zones of decalcification present on the patient's teeth (Fig 10 – Clinical case completed)
